**Flood Control Project Maintenance
Levee Inspections**

2018 Channel Summary Report

San Joaquin County Flood Control and Water Conservation District

Flood Control Project Maintenance**Unit Cover Sheet****2018 Channel Inspection Results****San Joaquin County Flood Control and Water Conservation District**

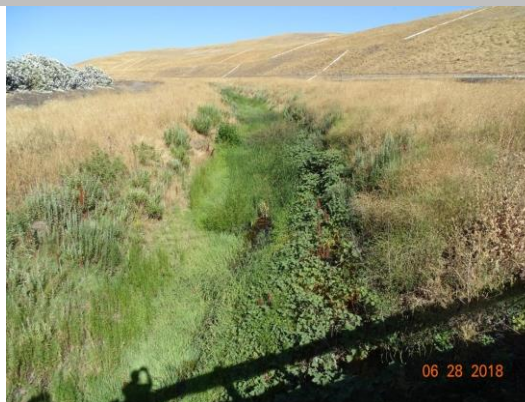
Inspector Comments: Minimal vegetation growth is found, but it does not appear to impede the flow of the channel.

View of the vegetation on the downstream end of the channel. Summer 2018

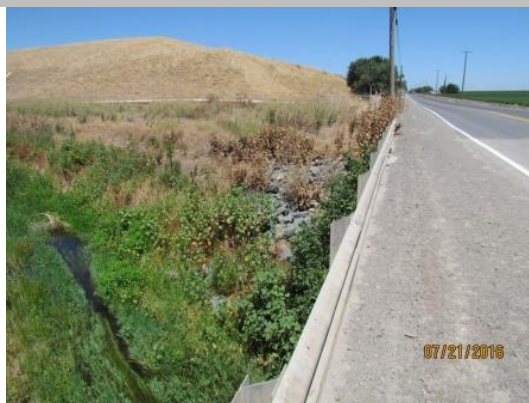
Rating **	A	Issue No.	79	GPS Lat/Long
Issue Type +	Ma	Location *		37.872720 °
Category	Rivers, Channels & Designated Flood			-121.183100 °
Item	Revetments			
DWR ID	DWR_NA0017_44_c_2012_79			
Action/Comments				
Inspector Comments: Existing revetments are properly maintained.

View of the revetments on the downstream of the channel.

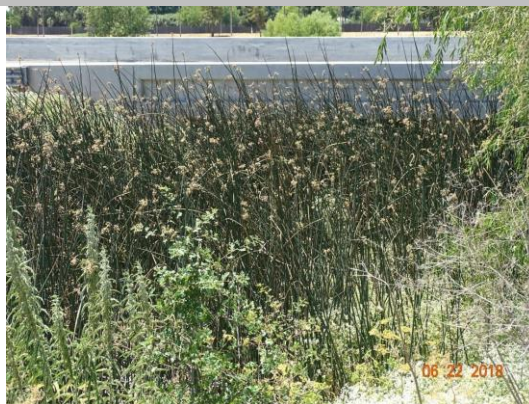
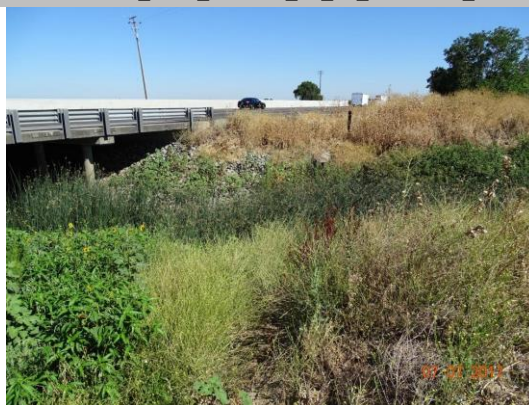
Inspector Comments: Vegetation growth may impede the flow of the channel.

View of vegetation on the upstream of the channel. Summer 2018

View of vegetation on the upstream of the channel. Summer 2017

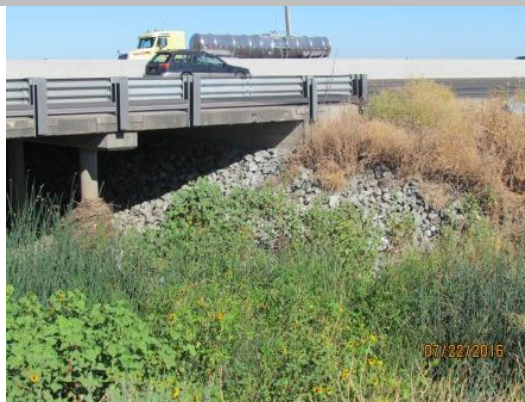
Rating **	A	Issue No.	84	GPS Lat/Long
Issue Type +	Ma	Location *		37.872077 °
Category	Rivers, Channels & Designated Flood			-121.219318 °
Item	Revetments			
DWR ID	DWR_NA0017_44_c_2012_84			
Action/Comments				
Inspector Comments: Existing revetments were properly maintained at this location. Unable to inspect in 2018 due to vegetation growth.

View of the existing revetments on the upstream end of the channel.

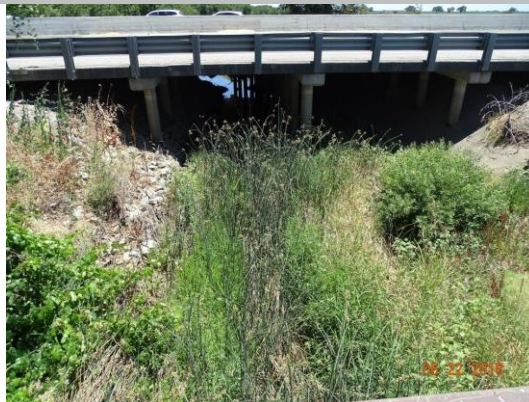
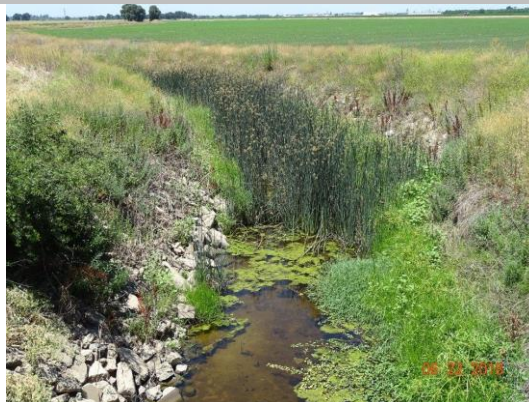
Inspector Comments: Vegetation may impede the flow of the channel.

View of the vegetation on the downstream side of the channel. Summer 2018

Another view of the vegetation on the downstream side of the channel. Summer 2018

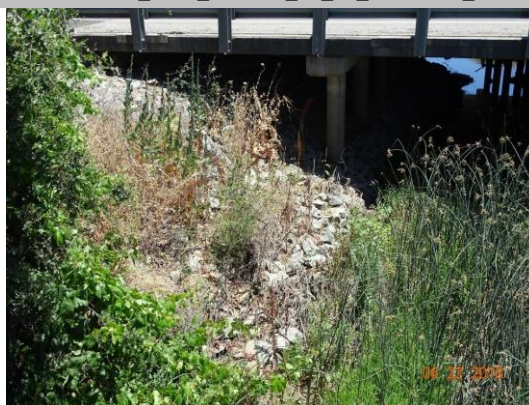
Rating **	A	Issue No.	89	GPS Lat/Long
Issue Type +	Ma	Location *		37.872077 °
Category	Rivers, Channels & Designated Flood			-121.219318 °
Item	Revetments			
DWR ID	DWR_NA0017_44_c_2012_89			
Action/Comments				
Inspector Comments: Existing riprap was properly maintained at this location.

View of the existing revetments on the downstream of the channel.
Summer 2018

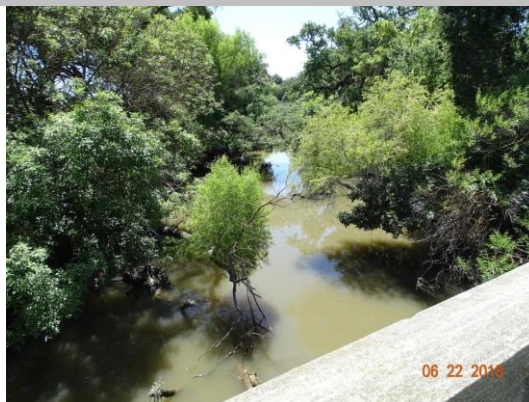
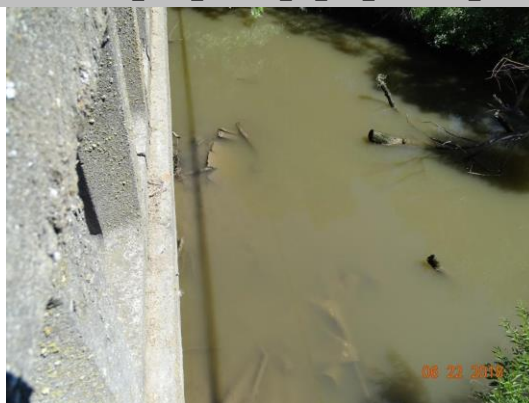
Inspector Comments: Tree limbs have fallen into the channel that may impede the flow.

View of the channel looking upstream. Summer 2018

View of the debris in the water looking upstream. Summer 2018

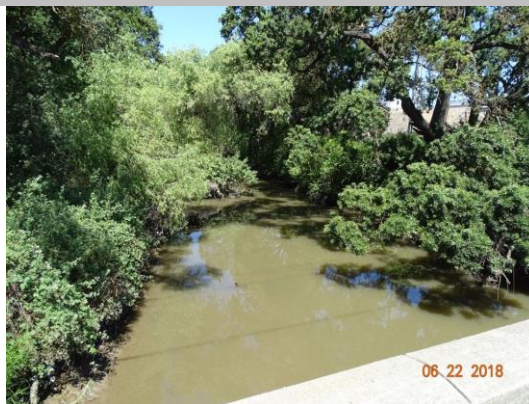
Photo 1 of 1 : CH_2018_NA0017_44_125_20180625_00067.jpg

Inspector Comments: Tree branches may fall into the channel, but the flow is not impeded.

View of the channel downstream during 2018 inspection.

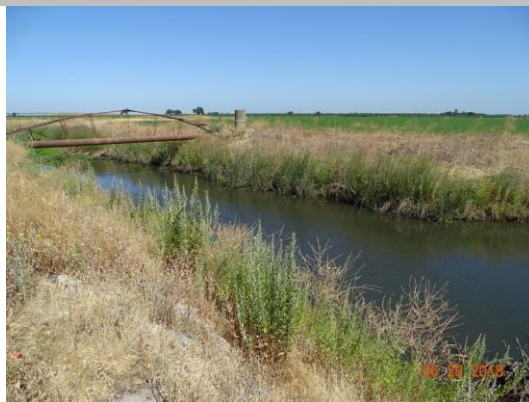
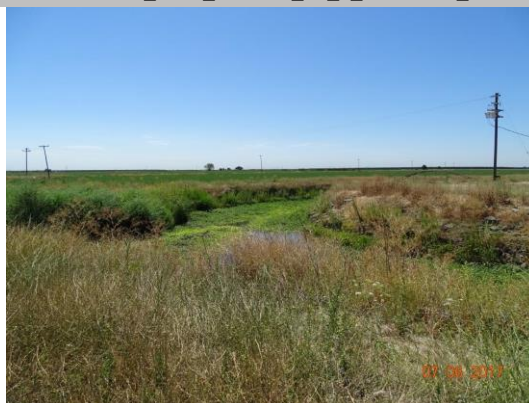
Rating **	A	Issue No.	6 (cont)	GPS Lat/Long
Issue Type +	Ma	Location *		37.888860 °
Category	Rivers, Channels & Designated Flood			-121.130320 °
Item	Vegetation & Obstructions			
DWR ID	DWR_NA0017_45_c_2012_6

View of the confluence looking downstream. Summer 2018

View of the confluence looking downstream.

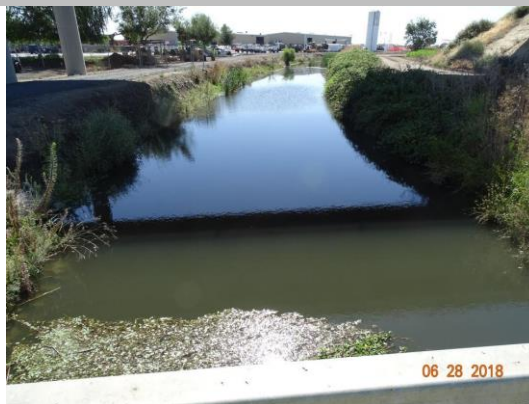
Photo 1 of 1 : CH_2018_NA0017_45_11_20180702_00035.jpg

Inspector Comments: Minimal vegetation in the channel should not impede the flow.

View of the channel looking upstream during 2018 inspection.

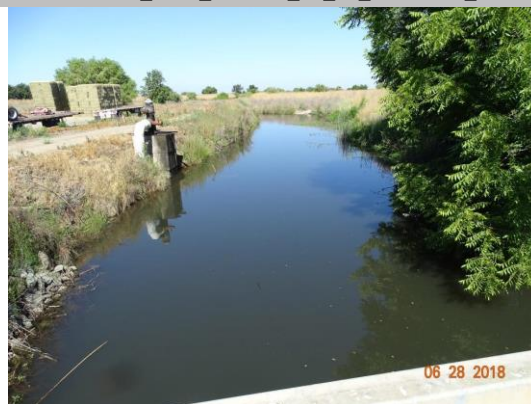
Photo 1 of 1 : CH_2018_NA0017_45_16_20180702_00036.jpg

Inspector Comments: Minimal vegetation in the channel should not impede the flow.

View of the channel looking downstream. Summer 2018

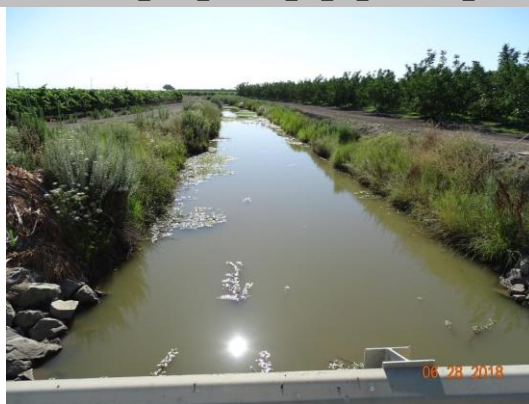
Photo 1 of 3 : CH_2018_NA0017_45_21_20180702_00030.jpg

Inspector Comments: Minimal vegetation in the channel should not impede the flow.

View upstream of the channel. Summer 2018

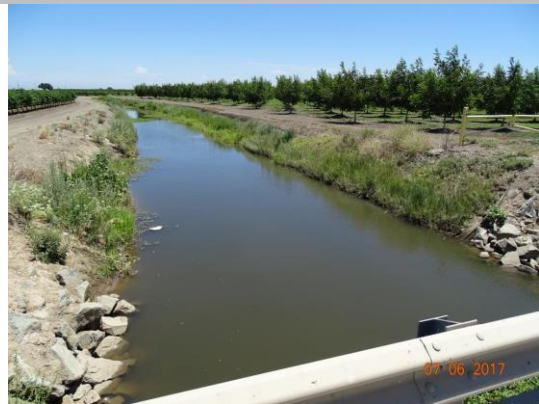
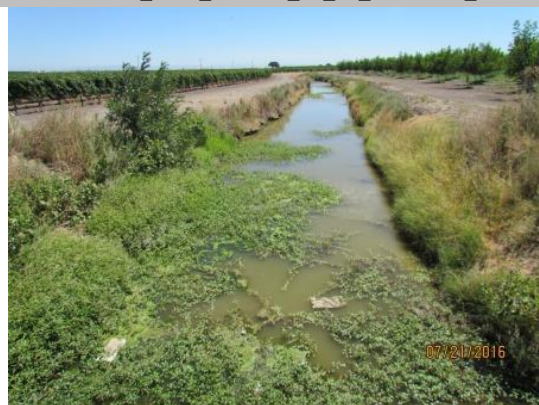
Inspector Comments: Minimal vegetation in the channel should not impede the flow.

View of the vegetation on the upstream of the channel. Summer 2017

View of the vegetation on the channel looking upstream during 2016 inspection.

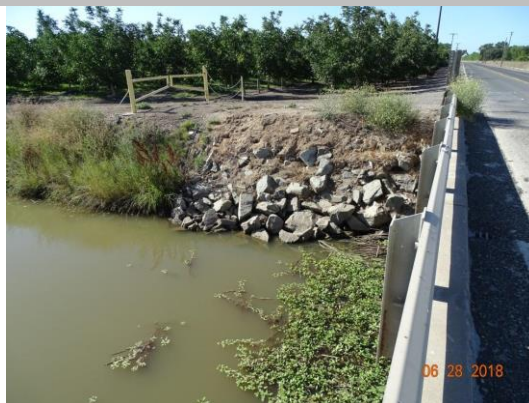
Photo 1 of 1 : CH_2018_NA0017_45_24_20180702_00031.jpg

Rating **	A	Issue No.	24	GPS Lat/Long
Issue Type +	Ma	Location *		37.886056 °
Category	Rivers, Channels & Designated Flood			-121.183664 °
Item	Revetments			
DWR ID	DWR_NA0017_45_c_2012_24			
Action/Comments				
Inspector Comments: LMA has placed revetments on both banks of the channel. Permit#19001. Existing revetments are properly maintained.

View of the revetments on the left bank of the channel. Summer 2018

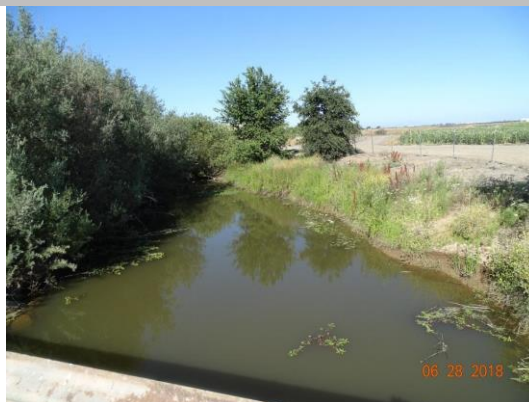
Photo 1 of 1 : CH_2018_NA0017_45_26_20180702_00032.jpg

Rating **	A	Issue No.	26	GPS Lat/Long
Issue Type +	Ma	Location *		37.886056 °
Category	Rivers, Channels & Designated Flood			-121.183664 °
Item	Vegetation & Obstructions			
DWR ID	DWR_NA0017_45_c_2012_26			
Action/Comments				
Inspector Comments: Willows and other woody vegetation should be trimmed back before it impedes channel capacity.

View of the channel downstream. Summer 2018

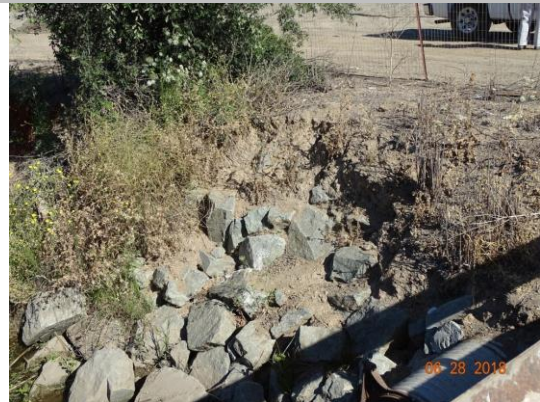
Photo 1 of 1 : CH_2018_NA0017_45_29_20180702_00034.jpg

Rating **	A	Issue No.	29	GPS Lat/Long
Issue Type +	Ma	Location *		37.886056 °
Category	Rivers, Channels & Designated Flood			-121.183664 °
Item	Revetments			
DWR ID	DWR_NA0017_45_c_2012_29			
Action/Comments				
Inspector Comments: LMA has placed riprap at this location. Permit #19001. Existing revetments are properly maintained.

View of the revetment on the right bank of the channel. Summer 2018

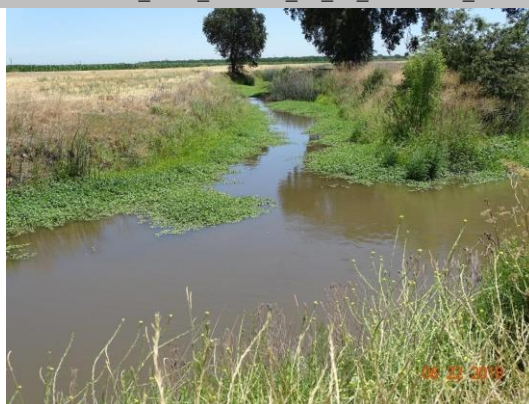
Photo 1 of 1 : CH_2018_NA0017_45_31_20180625_00022.jpg

Rating **	A	Issue No.	31	GPS Lat/Long
Issue Type +	Ma	Location *		37.876513 °
Category	Rivers, Channels & Designated Flood			-121.236231 °
Item	Vegetation & Obstructions			
DWR ID	DWR_NA0017_45_c_2012_31			
Action/Comments				
Inspector Comments: Minimal scattered vegetation is unlikely to impede the flow of the channel.

View of the confluence looking upstream. Summer 2018

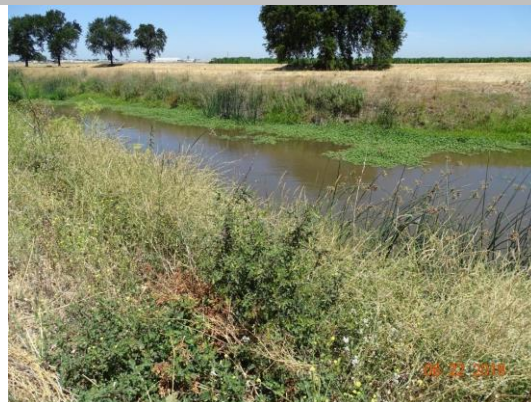
Photo 1 of 1 : CH_2018_NA0017_45_36_20180625_00023.jpg

Inspector Comments: Minimal scattered vegetation is unlikely to impede the flow of the channel.

View of the channel looking downstream during 2018 inspection.

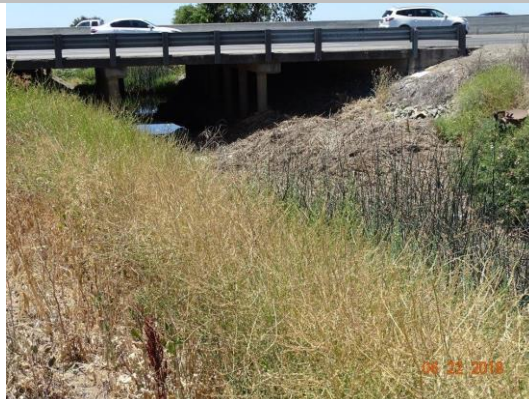
Photo 1 of 2 : CH_2018_NA0017_45_41_20180625_00026.jpg

Inspector Comments: Dense and woody vegetation may impede the flow of the channel.

View of the vegetation on the upstream side of the channel. Summer 2018

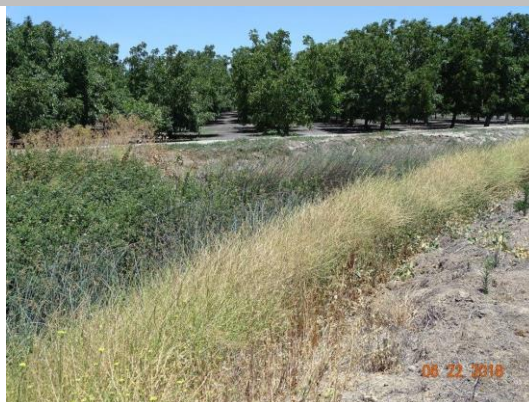
Photo 2 of 2 : CH_2018_NA0017_45_41_20180625_00029.jpg

Rating **	M	Issue No.	41 (cont)	GPS Lat/Long
Issue Type +	Ma	Location *		37.875127 °
Category	Rivers, Channels & Designated Flood			-121.219201 °
Item	Vegetation & Obstructions			
DWR ID	DWR_NA0017_45_c_2013_41			
Action/Comments				
Inspector Comments: Dense and woody vegetation may impede the flow of the channel.

Another view of the vegetation on the upstream side of the channel.
Summer 2018

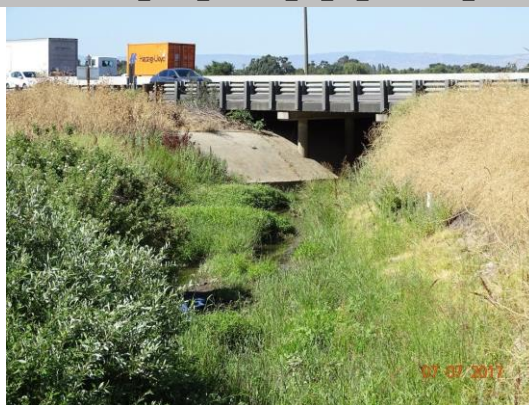
Photo 1 of 1 : CH_2018_NA0017_45_43_20180530_00019.jpg

Rating **	A	Issue No.	43	GPS Lat/Long
Issue Type +	Ma	Location *		37.875127 °
Category	Rivers, Channels & Designated Flood			-121.219201 °
Item	Revetments			
DWR ID	DWR_NA0017_45_c_2013_43			
Action/Comments				
Inspector Comments: Existing revetments were properly maintained.

View of the existing revetment looking upstream.

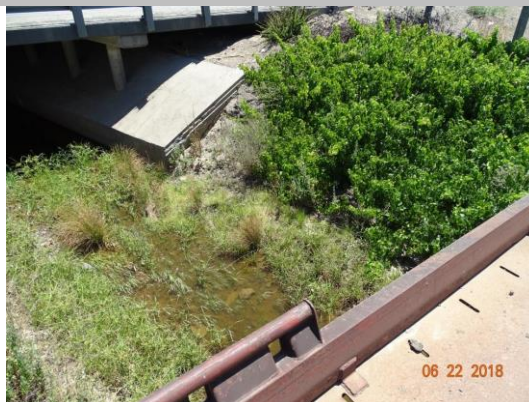
Photo 1 of 1 : CH_2018_NA0017_45_45_20180625_00025.jpg

Rating **	A	Issue No.	45	GPS Lat/Long
Issue Type +	Ma	Location *		37.875127 °
Category	Rivers, Channels & Designated Flood			-121.219201 °
Item	Vegetation & Obstructions			
DWR ID	DWR_NA0017_45_c _ 2013_45			
Action/Comments				
Inspector Comments: Vegetation in the channel should not impede the flow.

View of the channel looking downstream. Summer 2018

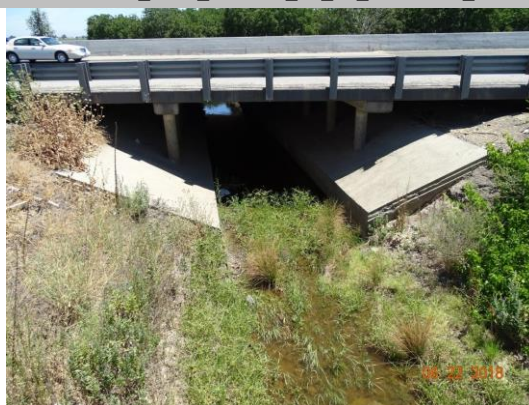
Photo 1 of 1 : CH_2018_NA0017_45_48_20180625_00024.jpg

Rating **	A	Issue No.	48	GPS Lat/Long
Issue Type +	Ma	Location *		37.875127 °
Category	Rivers, Channels & Designated Flood			-121.219201 °
Item	Revetments			
DWR ID	DWR_NA0017_45_c_2013_48			
Action/Comments				
Inspector Comments: Existing revetments were properly maintained.

View of the revetments on both banks looking at the downstream side of the channel. Summer 2018
